## **Confidential Inspection Report**

**2222 Dorothy Lane**  
**Everywhere, USA**

**Prepared for: John & Jane Doe**

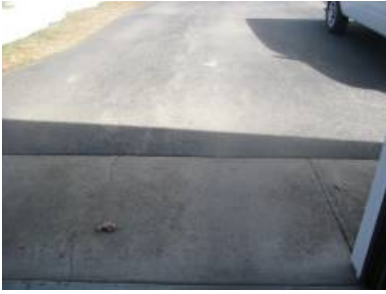
<i>Driveway:</i>	Functional. Performing function as intended. Materials Noted; Material: Concrete. Material: Asphalt. Observations: Typical settling cracks noted.
------------------	---

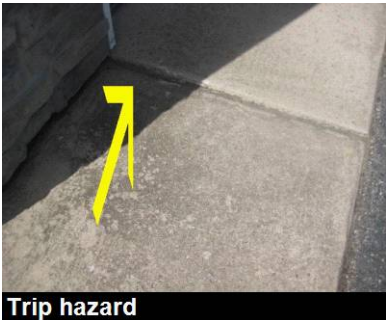
Trip hazard

Functional. Performing function as intended. Materials Noted; Concrete. Asphalt. Brick. Observations: Typical settling cracks noted. Sections of the walkway have settled. Sections are offset from each other creating a potential trip hazard.

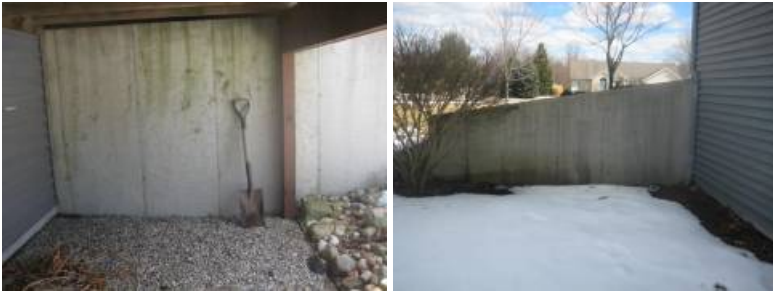
*Materials Used:* The retaining wall is made of concrete.

*Condition Of Wall And Materials Used:* Functional. Performing function as intended.

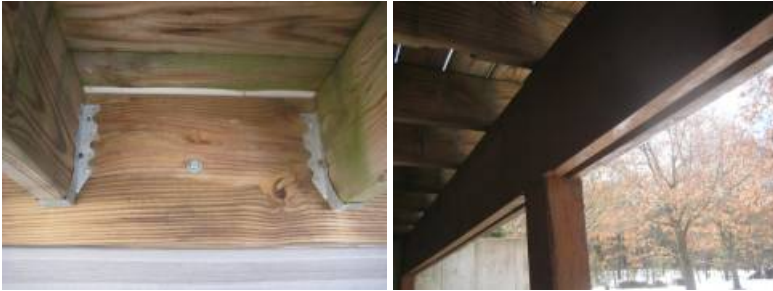
*Framing Of Deck:* Functional. Performing function as intended. Ledger board is lag bolted to the home. Main ledger board is adequately flashed. Flashing is visible and appears to be done correctly and is in all need areas. Joist Hangers: Functional, no noted problems.

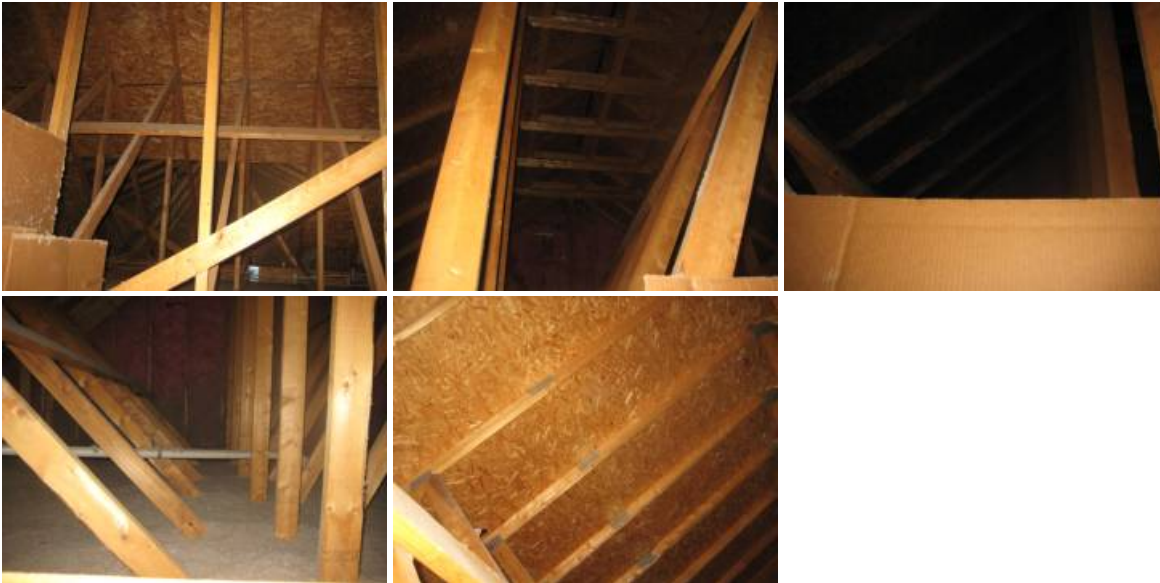
*Roof Framing:* Functional. Performing function as intended. A truss system is installed in the attic cavity that is used to support the roof decking and transmit the roof load to the exterior walls. The rafter spacing is 24 inch on center.

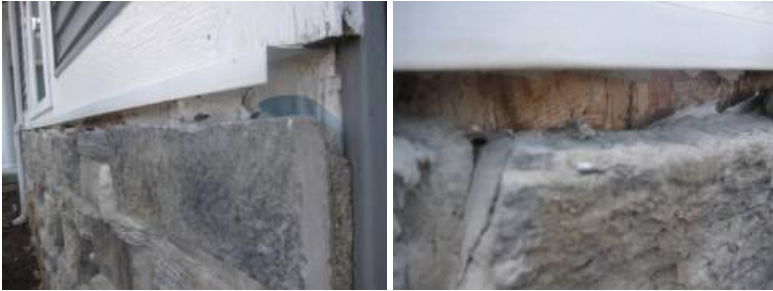
*Siding Condition:* Lacks Maintenance: Sections of cultured stone are missing, exposed OSB sheathing noted.

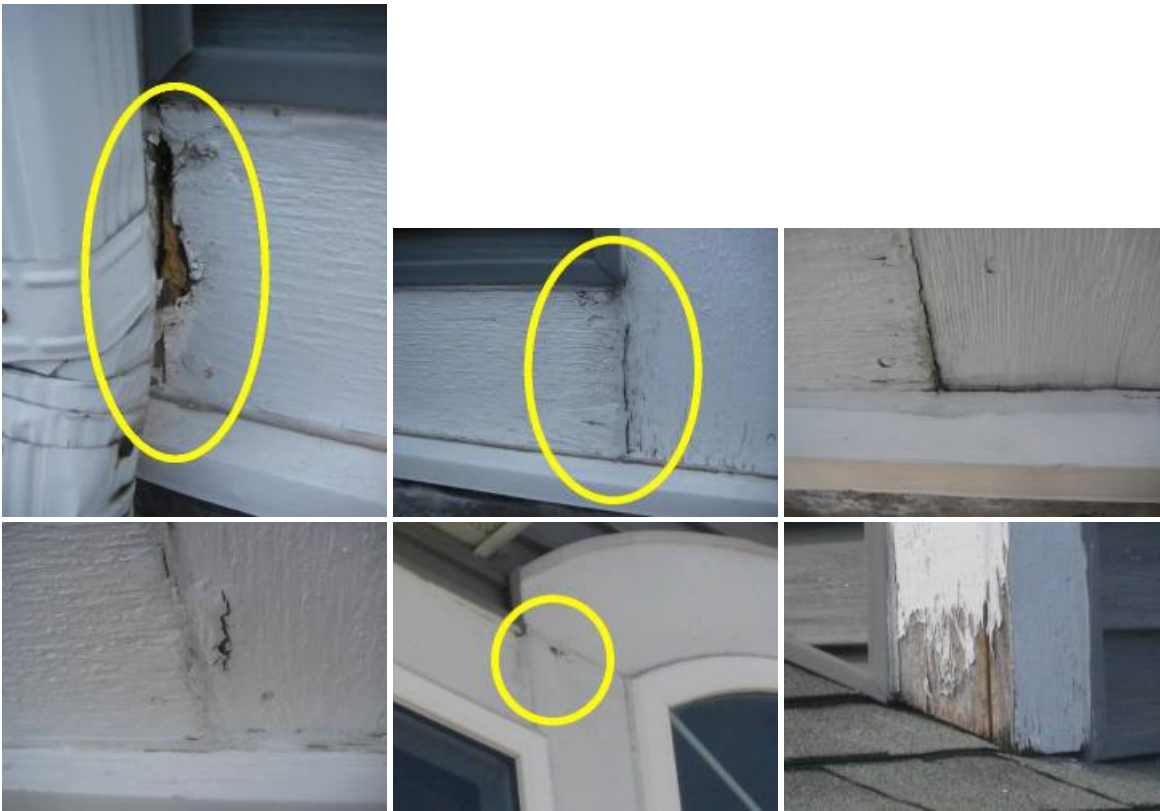
Lacks Maintenance: [Areas of significant dry rot noted.](#)

Areas of relatively minor dry rot noted. Moist, damp wood will attract carpenter ants leading to a potential infestation.

Areas of peeling paint noted.

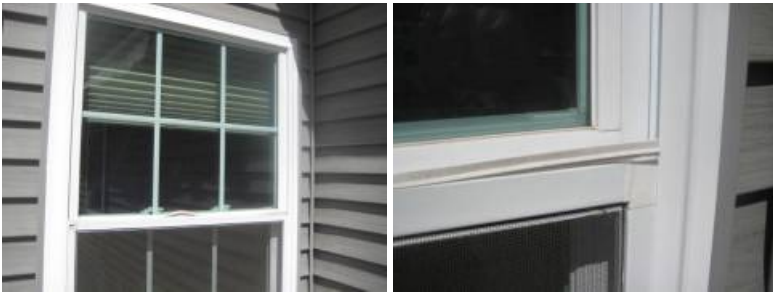
*Window Condition:* Lacks Maintenance: Insulation Seal - One or more insulated glass windows have lost their vacuum seal. As a result of losing this seal, condensation between the two panes creates a clouded or streaked appearance. The window still performs the task of keeping the weather out, but it has lost much efficiency.

Loose trim/weather-stripping noted.

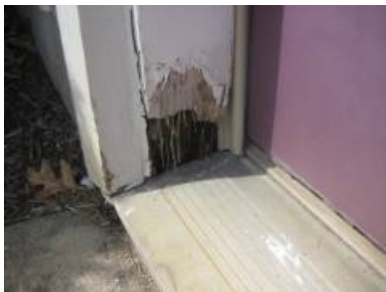
*Outside Entry Doors:*                      Lacks Maintenance: Areas of significant dry rot noted.

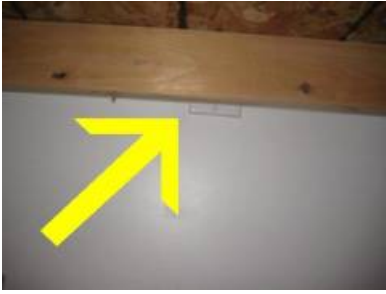
*Gfci Protection:* **GFCI protected outlets noted. GFCI function tests normal. (GFCI outlet is hidden behind permanent shelving, the GFCI was tripped when testing the exterior outlets. Was unable to reset the GFCI**

outlet.

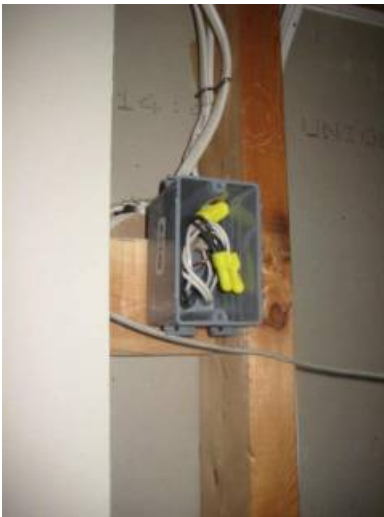
Junction box cover(s) are missing.

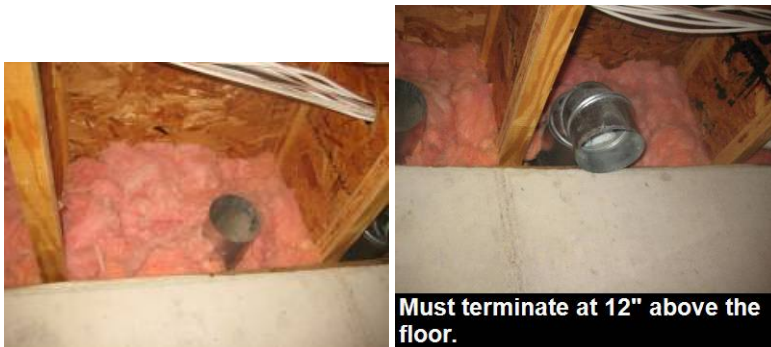
**Unsafe: Vents are blocked, plugged up with rags. This can lead to a carbon monoxide build-up in the home from the water heater and or furnace due to inadequate mack-up air in the Combustion Appliance Zone. This is a serious safety hazard. The extension of the one vent has been removed and no longer terminates with in 12" of the floor.**

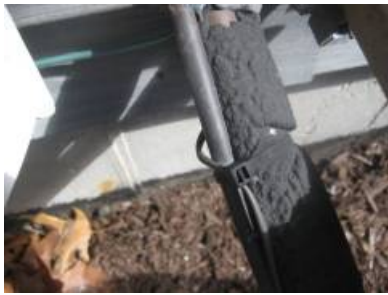
*Fuel Source:* 220 Volt, Electrical disconnect present.  
*Approx. Age:* Manufactured: 2001.  
*Condensate Line:* Functional. Performing function as intended.  
*Refrigerant Line:* Insulation on exterior portion of the line is in need of replacement.
